# Manhole Inspection Summary

Manhole # S35Q\_\_039MH

**Location** Address: **1034 s. hanover st**

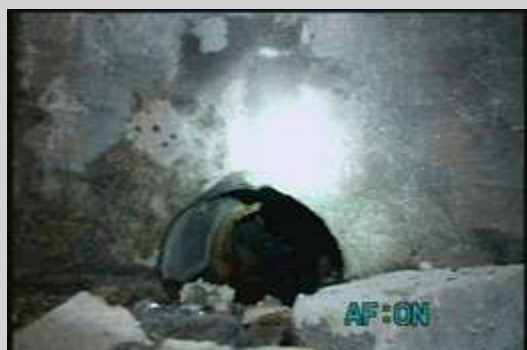
12 O'Clock Outflow

8 in. Circular Gravity Sewer  
Pipe Out @ 12 O'Clock

Infiltration: **None** Pipe Seal Cond: **Unknown**
